Final report of the BDIZ EDI implant study 2014/15

SEM surface analyses of 120 sterile-packed implants

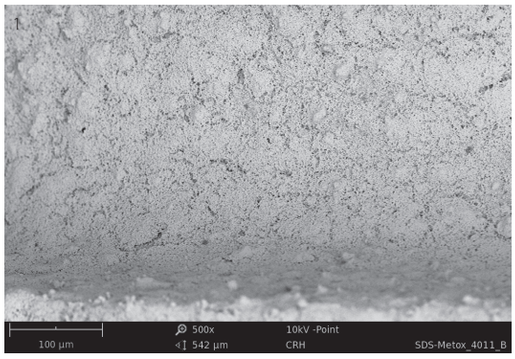
1 I
SDS – Metoxit (x 500).

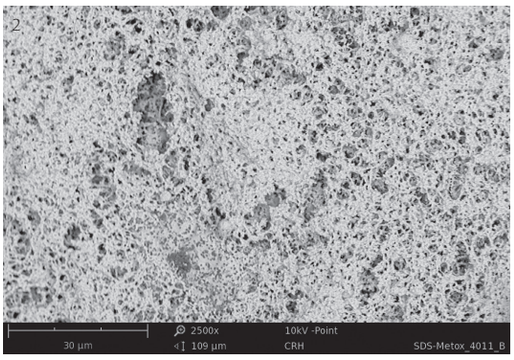
2 I
SDS – Metoxit
(x 2,500).

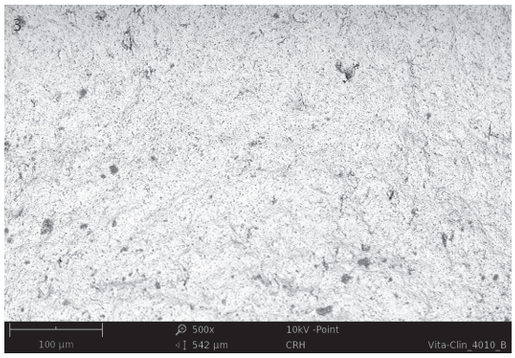
3 I
vitaclinical
(x 500).

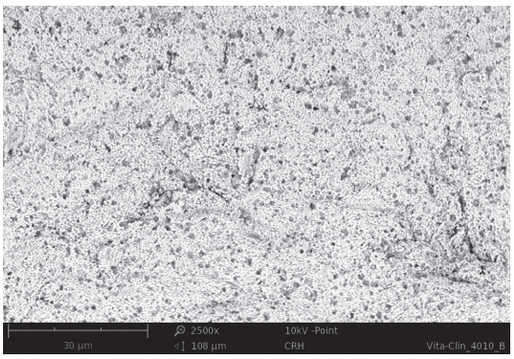
4 I
vitaclinical
(x 2,500).

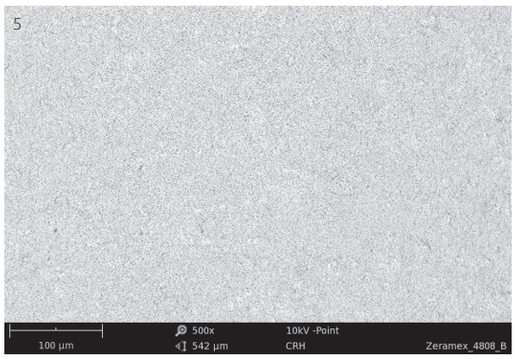
5 I
Dentalpoint –
Zeramex (x 500).

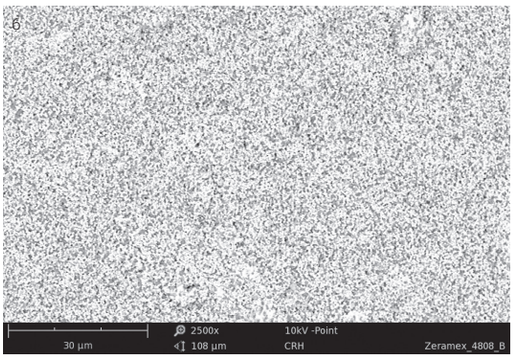
6 I
Dentalpoint –
Zeramex (x 2,500).

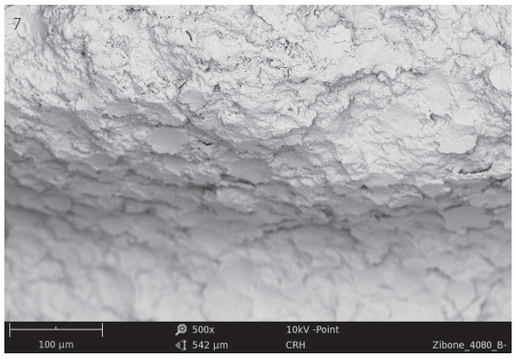
7 I
Zibone – Coho
(x 500).

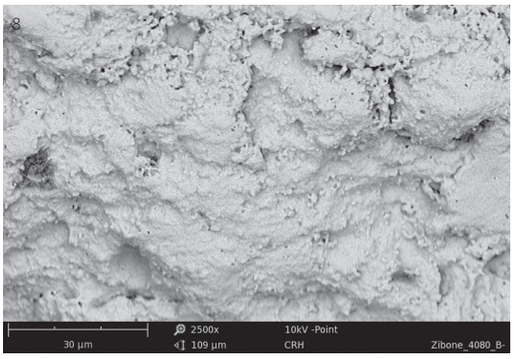
8 I
Zibone – Coho
(x 2,500).

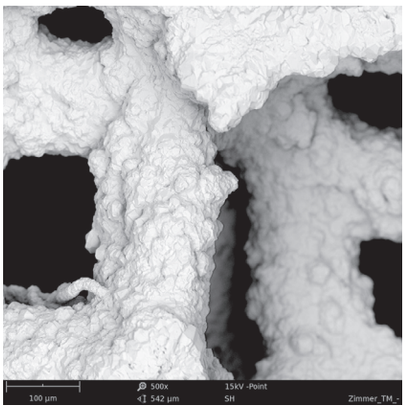
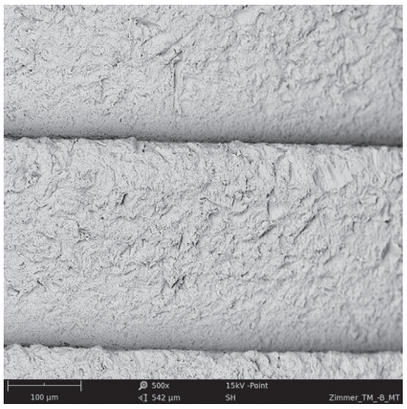
17 I Trabecular midsection made of tantalum (Zimmer Trabecular Metal implant, x500).

18 I The shoulder and apex of the same implant are made of titanium (Zimmer Trabecular Metal implant, x500).

One tantalum-titanium hybrid implant in this study exhibited a rather particular surface topography. While the titanium surface of the implant shoulder and its apical region had been blasted with hydroxyapatite, the middle segment of the implant, marketed by the manufacturer as "trabecular metal", had a porous structure not unlike cancellous bone. This three-dimensional structure is based on a glassy carbon framework completely coated with tantalum. The corrosion-resistant tantalum [11] has been successfully used as an orthopaedic implant material for many years. Now also used in dental implants, the special surface texture is designed to allow the ingrowth of bone cells into the depth of the structure [12,13]. The term "osseoincorporation" has been coined in the literature in an attempt to add a third dimension to *Brånemark's* definition of osseointegration [14]. Prospective multicentre studies at 22 locations in five European countries have shown that the clinical success rates of hybrid implants made of titanium and tantalum were similar to those of pure titanium implants [15]. The only representative of this class of materials in the current study was the tantalum-titanium hybrid implant by Zimmer (Figs. 17 and 18).

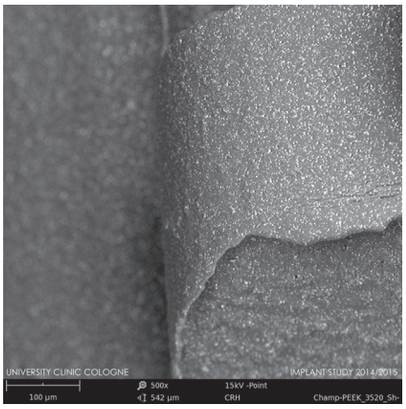
19 I Implant made of polyether ether ketone (Champions WIN! PEEK implant, x500).

Polyether ether ketone (PEEK) has more recently been used as a new material for dental implants (Fig. 19). As the material has only been used for dental implants for a rather short time, only few reports are extant. In-vitro trials suggest that the mechanical properties of PEEK might optimize the distribution of masticatory forces through the implant's surroundings [16,17]. Here we will have to wait for long-term clinical results. Only one implant made of PEEK was included in the study; a second manufacturer had not responded to our enquiries.

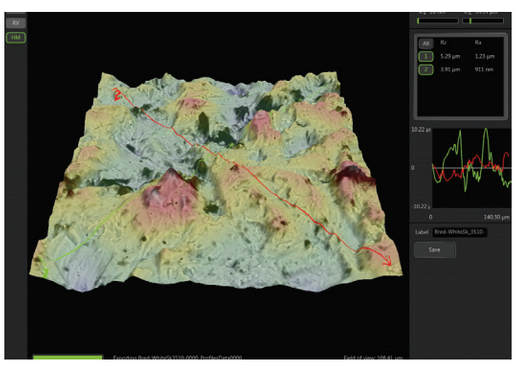
20 I 3D roughness reconstruction (Bredent WhiteSKY, x2,500).

To document the surface roughness of each of the investigated implant systems, a so-called 3D roughness reconstruction was performed that allows a visual comparison of the respective surface structures. During the imaging process, the three-dimensional shape of the object is calculated from the brightness distribution in the grid of the four quadrants of the backscattered electron detector (Fig. 20).

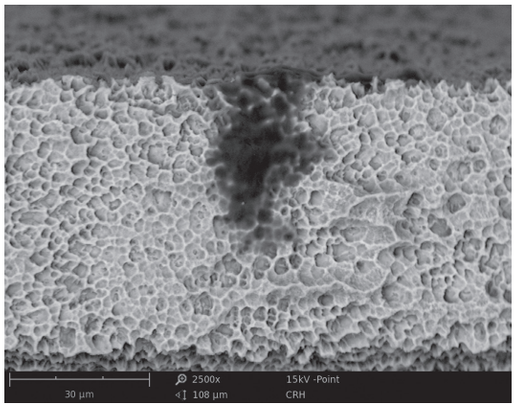
21 I "Single spot", individual organic contaminant (x2,500).

Minor amounts of carbonaceous residue remaining on the implant after the cleaning process are a not infrequent finding. Organic residue appears darker in the material contrast image than titanium or zirconia because carbon atoms have fewer electrons and therefore create fewer backscattered electrons in a SEM than atoms of higher atomic numbers. Soft, sometimes jagged edges are typical of organic contaminants. If there are only a few isolated spots like that, they will make up only a very small part of the total area, being of little consequence and no clinical relevance (Fig. 21). The figure shows a single organic impurity 10 to 20 µm in size on an otherwise largely residue-free implant. More conspicuous were systematically distributed organic residues on several implants that are in contact with their outer packaging. These typically featured circumferential organic contamination occurring only at the outer edge of the thread (Figs. 22 to 24), which suggests that contact with the packaging could be responsible.

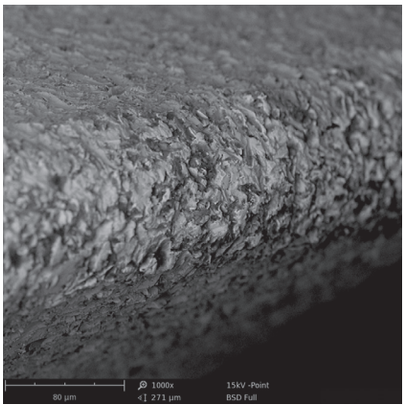
22 I Circumferential organic residue on a titanium implant (x500).

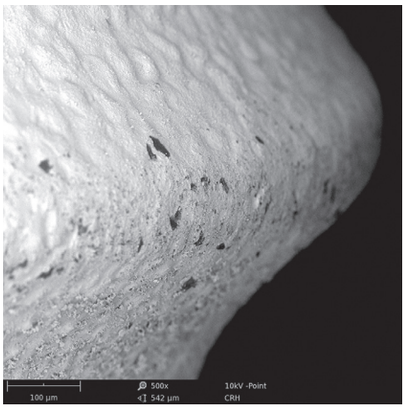
23 I Organic residue on the outer thread structures (zirconia, x500).

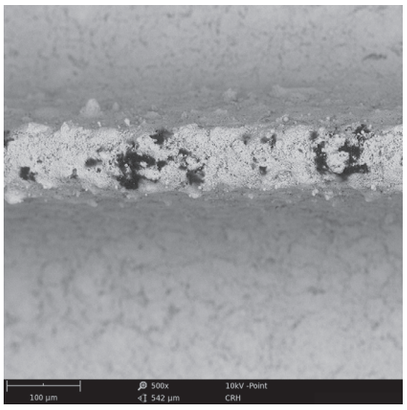
24 I Superficial organic particles (zirconia, x500).

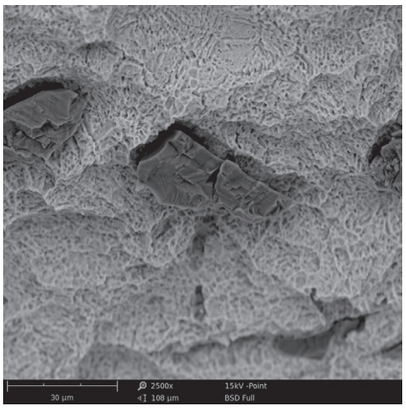
25 I Individual inclusions of sandblasting material (titanium, x2,500).

Some isolated implants exhibited inorganic residue from the sandblasting process, namely alumina particles 20 to 30 µm in size (Fig. 25), but in quantities of presumably limited clinical relevance.

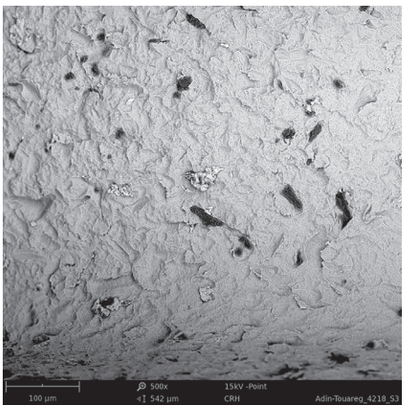
Unexpected inorganic residue findings included, in addition to the iron-copper-chromium particles described in the first part of the report, larger areas with intermittent chromium-nickel-steel particles 4 to 30 µm in size on one of the implants studied. The material contrast image had already presented them as strikingly bright and well-defined structures. These metallic particles might have originated as impurities within the blasting material or as abrasion residue from the CNC cutting tools that were subsequently embedded in the implant surface to the point where cleaning could not remove them (Figs. 26 and 27). Three spot analyses were carried out as part of the qualitative and quantitative elemental analysis (Fig. 28). The analysis of the chromium-nickel-steel particle

26 I Implant surface (Adin Touareg) with notable light and dark particles (x 500).

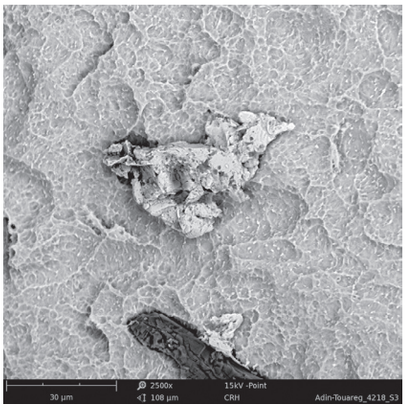
27 I Same implant surface (Adin Touareg): bright chromium-nickel-iron particle, dark aluminium oxide particle (x 2,500).

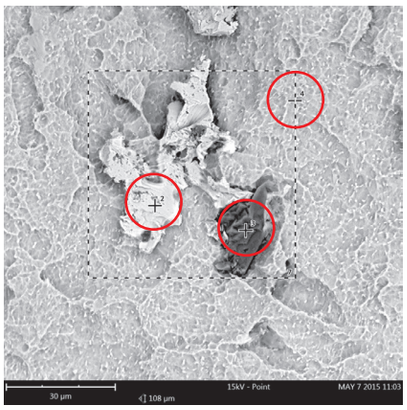
28 I Marks for EDX spot analysis and EDX mapping area (Adin Touareg; x 2,500).

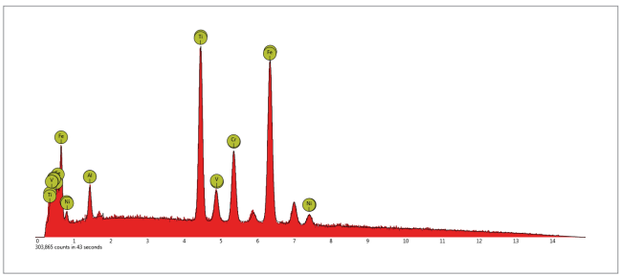
29 I Qualitative elemental analysis, spot no. 2 (bright chromium-nickel-iron particle).

Atomic percentage	Certainty
Fe	49.8%	0.99
Ti	24.5%	0.99
Cr	13.6%	0.99
Al	5.6%	0.97
Ni	5.2%	0.96
V	1.3%	0.94

(spot no. 2) has typical "fingerprints" for the elements iron, nickel and chromium (Fig. 29 and Table 2). As expected, the dark particle turns out to be alumina (Fig. 30 and Table 3), while the control area outside the two particles (spot no. 4) shows only the typical signs for grade 5 titanium (titanium, aluminium and vanadium) (Fig. 31 and Table 4).

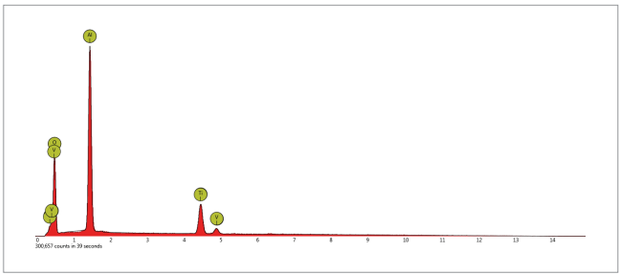
30 I Qualitative elemental analysis, spot no. 3 (bright aluminium oxide particle; sandblasting residue).

Atomic percentage	Certainty
O	68.2%	0.99
Al	25.3%	1.00
Ti	6.1%	0.99
V	0.4%	0.93

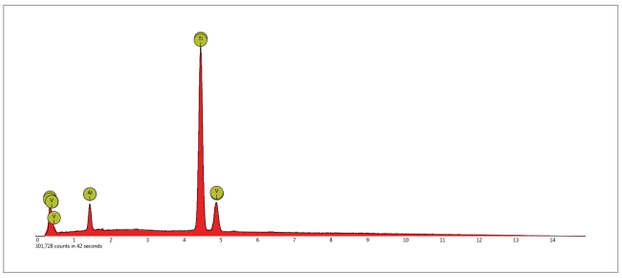
31 I Qualitative elemental analysis, spot no. 4 (particle-free implant surface, grade 5 titanium).

Atomic percentage	Certainty
Ti	85.7%	1.00
Al	11.5%	0.99
V	2.8%	0.94

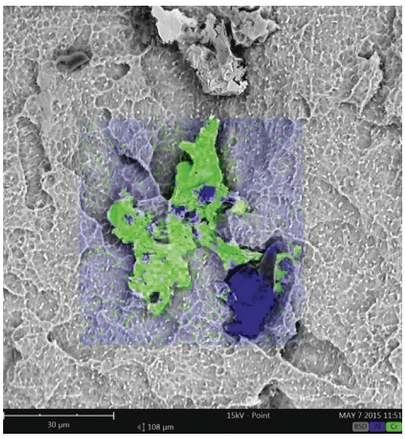
32 I Example of EDX mapping: green = chrome; blue = aluminium (Adin Touareg; x 2,500).

tal signal its own colour, which can then be superimposed on the SEM image as a coloured overlay. Figure 32 shows the detected chromium in green and aluminium in blue.

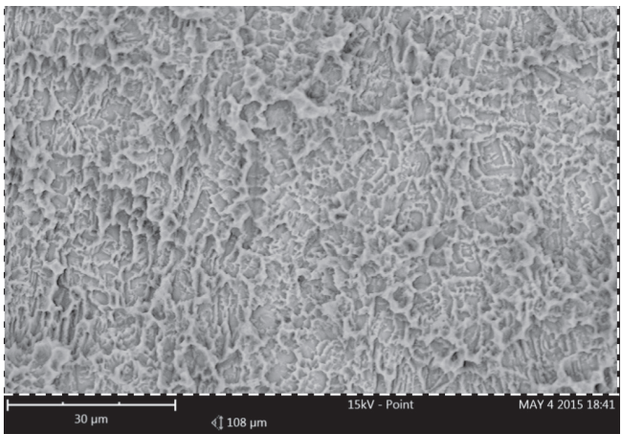
44 I Camlog – Conelog, EDX area analysis (x2,500).

magnification in Figures 33 to 42. The continuous improvement process in Camlog implants deserves special mention. While the samples analyzed in 2008 showed residues of blasting material on up to ten per cent of the total surface, the figure for 2011 was less than three per cent for the same implant type. In the current study, all three implant models (Camlog, Conelog and iSy) exhibited completely residue-free surfaces in the elemental analysis. Thus, the spectrum of the EDX analysis of the Conelog implant surface indicates only titanium (Figs. 43 to 45).

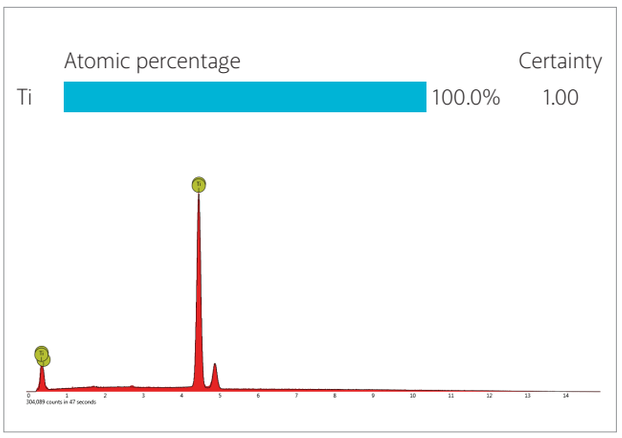
45 I Quantitative and qualitative elemental analysis of the Camlog Conelog implant surface (pure titanium).

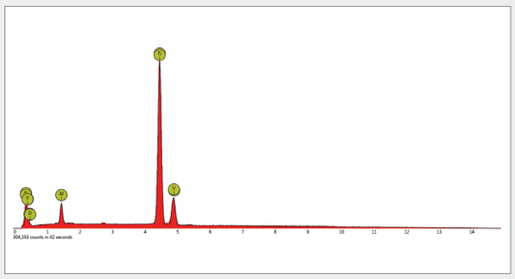
Only X-ray photoelectron spectroscopy (XPS) can produce such sensitive evidence in layers 5 to 10 nm in thickness. The kinetic energy of the photoelectrons of an atom is measured to determine its binding energy, which is characteristic of the atom from which the electron emanates. This can be used to determine whether the cleaning process after acid etching of the implant surface has left traces of acid or if the water used for the cleaning itself was clean enough.
An Israeli manufacturer (Paltop) has decided to consistently clean their products with ultra-pure water (UPW), which is rather expensive to produce compared to regular demineralized water and is otherwise mostly employed by the semiconductor industry. XPS analyses of the implant surfaces thus cleaned show no traces of sulphur, silicon, zinc or chlorine, inorganic impurities not infrequently found in the XPS analyses of the sandblasted and acid-etched surfaces of implants by other manufacturers investigated in 2014 as the corresponding ISIS identification cards were prepared [22]. The material contrast image showed no residue on the Ti-6AL-4V ELI implant (Figs. 46 and 47). The corresponding EDX analysis shows only the typical elements for grade 5 titanium (Fig. 48 and Table 5).

48 I EDX spectrum for the Paltop implant.

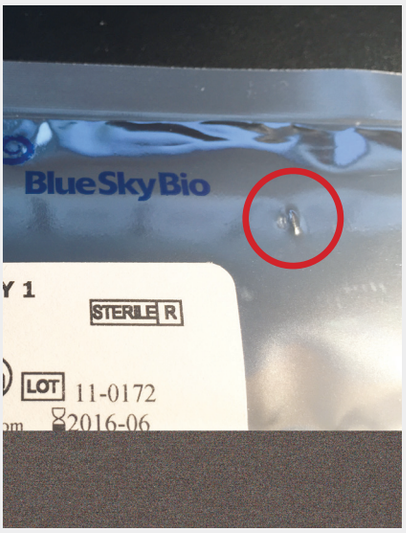
On the one hand, there are uncompromising elaborate constructions that offer safe handling and are sure to eat into the manufacturer's profit margin (Fig. 49). The illustration shows a complex packaging design where the implant is inserted in a separate sleeve made of the same material (grade 5 titanium) as the implant itself to reduce the influence of other materials to a minimum.
On the other hand, there are simple packaging solutions where the implant is simply sealed in a double plastic bag and the manufacturer seems to have deemed even a stabilizing outer wrapper such as a blister pack to be too costly. Figure 50 shows a sterile package compromised by a sharp-edged cover screw.

50 I Sterile packaging compromised by a sharp-edged cover screw (BlueSkyBio).
